## IMPLEMENTATION OF DMAIC FRAMEWORK TO REDUCE DEFECTS IN SPRAY PAINTING PROCESS

**Sarah Ayu Aqila<sup>1</sup>, Nur Budi Mulyono<sup>2</sup>**

Institut Teknologi Bandung, Indonesia

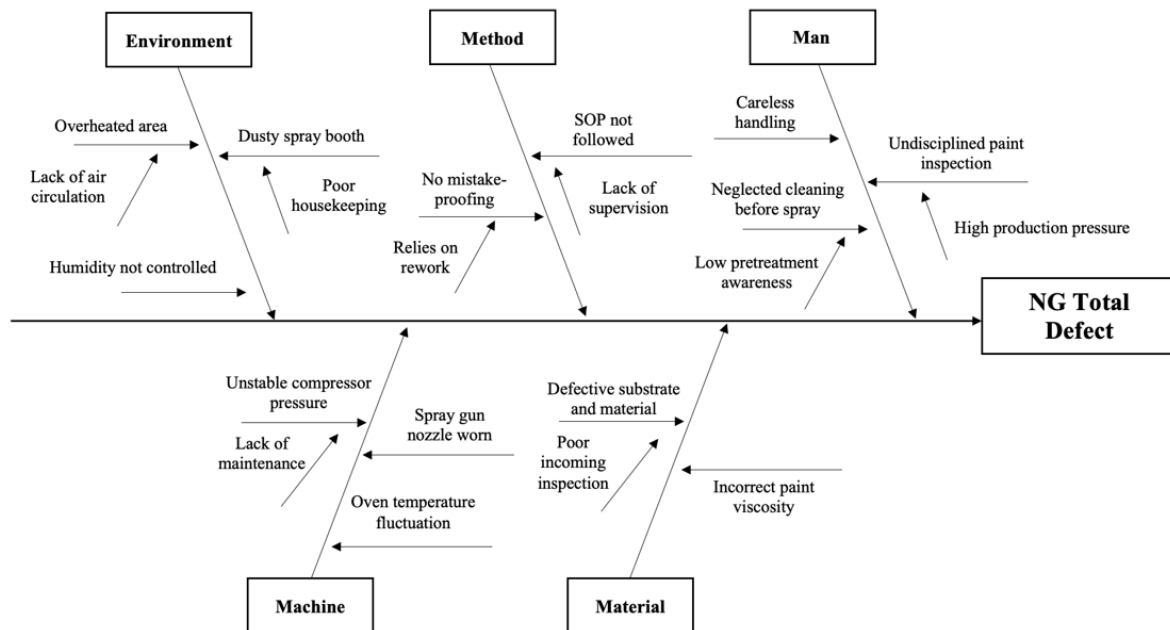
**Figure 1. Fishbone Diagram of NG Total Defect**

The results of root cause analysis of the method factor show that there is a possibility of inconsistency in the implementation of SOPs by some operators, such as SOPs that should serve as a reference in executing spray techniques, spray distance, and inspection steps. Weak supervision from direct superiors or supervisors also contributes to this issue because no direct follow-up or correction is carried out during the process. In addition, the absence of a mistake-proofing system (poka-yoke) in the work area causes repeated errors and prevents them from being systematically avoided. Under such conditions, quality control relies more on the rework process than on efforts to prevent defects from the beginning, resulting in repeated mistakes in the next period.

Next is the analysis of the material factor. The use of paint materials with viscosity that does not meet standards becomes one of the contributors to NG Total defects. This mismatch is caused by the inconsistency in conducting viscosity tests before the painting process begins, resulting in paint that is too thick and unable to spread evenly, producing a final surface that does not meet quality standards, including over paint and severe under paint defects. In addition, it was found that the base material or metal substrate to be sprayed sometimes already has physical defects from the beginning, such as fine scratches, small dents, or invisible contamination. This occurs because the incoming inspection process is not conducted thoroughly or in detail, allowing defective material to pass into the painting stage. Defects on the substrate or mismatched paint eventually result in a final product that cannot be repaired through rework and is directly categorized as NG total.

From the machine factor, it was found that several machine conditions in the production line do not support the stability of the painting process. One of the main root causes is the condition of spray gun nozzles that are worn or dirty due to lack of daily inspection and cleaning. Nozzles that are not in optimal condition cause uneven paint distribution, resulting in surface defects that are difficult to correct. In addition, unstable air pressure in the compressor was found, which is caused by a lack of regular preventive maintenance. This instability

directly impacts the irregularity of paint flow during spraying, increasing the risk of under paint or severe bubbles that lead to NG total. Another problem is found in the stability of the drying oven temperature, where inaccurate control settings cause temperature variations during the drying process. If not properly addressed, this can result in serious defects such as large bubbles or paint that does not adhere perfectly to the material.

Observations in the production area show that the discovery of a significant amount of dust, especially in the spray booth area, becomes one of the root causes of NG total defects. This is caused by weak housekeeping programs and ineffective air circulation control. Dust particles that stick to the surface of materials before or during the painting process can disrupt paint adhesion, preventing the paint from sticking well to the surface and potentially resulting in severe defects that are difficult to fix. In addition, the excessively hot working area temperature due to suboptimal ventilation and cooling systems accelerates the drying of paint before its time, causing uneven paint distribution and increasing the risk of defects such as large bubbles or cracked paint layers. Uncontrolled air humidity also becomes a contributing factor to serious defects, as high humidity levels can interfere with the quality of the paint layer and cause imperfections in the final result.

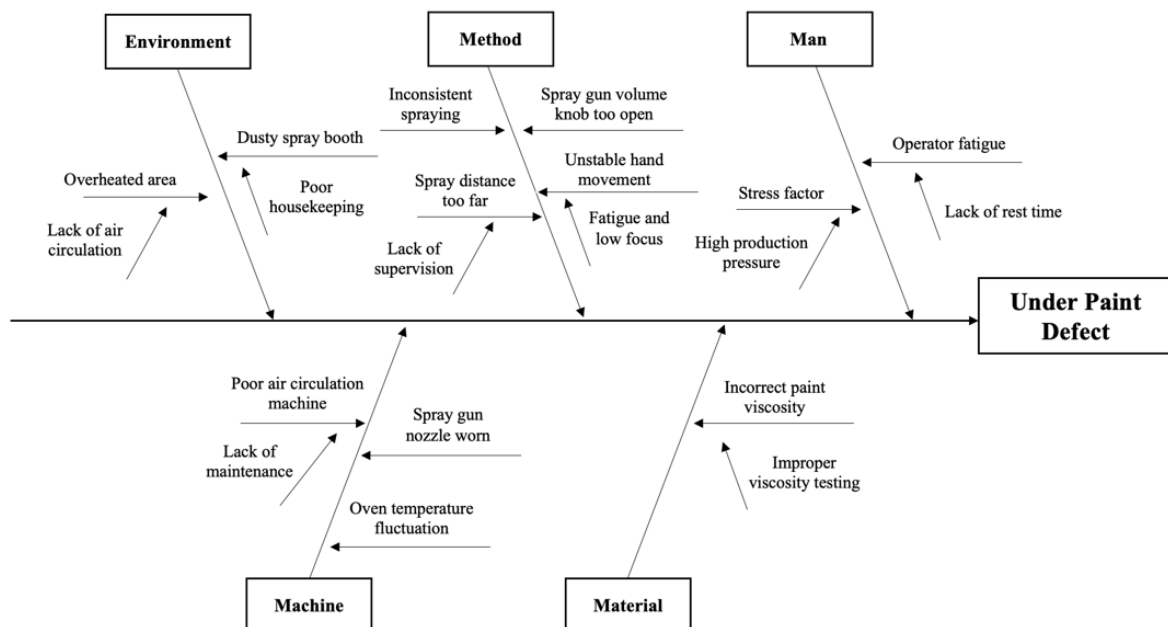
**Figure 2. Fishbone Diagram of Under Paint Defect**

Figure 2 shows the analysis results of the under paint defect, which groups various possible causes into five main factors. The human factor is a cause of Under Paint defects, in which the physical and psychological condition of the operators during the painting process has an impact on the quality of the paint layer. Based on discussions with the operator and field observations, it was found that operator fatigue due to lack of rest time is the cause of the decline in consistency in spraying techniques. This fatigue leads to reduced focus, unsteady hand movements, and irregularity in spray distance and direction, resulting in paint layers that are too thin. In addition, high production target pressure also creates stress that drives operators to work in a rushed manner and tends to ignore quality aspects. This combination of physical fatigue, psychological pressure, and minimal control over work speed makes the human factor a significant contributor to the occurrence of under paint defects that do not meet quality standards.

From the method factor, it was found that inconsistency in spraying techniques is the main root problem in this category. This factor is also related to the human factor. Operators often do not apply work methods consistently, such as variation in hand movement patterns, spray direction, and speed during the painting process. This is exacerbated by the improper setting of spray volume. The spray gun volume knob being too wide open causes uncontrolled paint distribution and uneven thickness. Additionally, spraying from a distance that is too far from the material surface also becomes an uncorrected habit, which results in thin paint layers. These issues should be minimized through more active supervision, but weak control in the field causes work practices that deviate from the standard to continue. As a result, the same mistakes keep recurring in the next processes, and the defects remain unresolved.

From the analysis of the material factor, it was found that the main root cause in this category is the use of paint with viscosity that does not meet the standard. This discrepancy occurs because viscosity testing is not carried out properly or is even ignored before the painting process begins, so paint that is too thick cannot spread evenly on the material surface. Paint layers that do not spread properly will result in areas that are too thin (under paint) and do not meet the expected thickness specification. This viscosity mismatch is not only caused by operator negligence but also indicates weak standards for material testing procedures before the production process. In the long term, the use of materials with uncontrolled physical characteristics will continue to increase the risk of recurring under paint defects.

The machine factor also significantly contributes to the occurrence of under paint defects. The analysis results show that several equipment conditions directly affect the thickness of the paint result. One of the root causes is worn or dirty spray gun nozzles, which result in uneven spray patterns and inconsistent paint distribution. This condition occurs due to a lack of routine inspection and equipment cleaning, so spray gun components are not always in optimal condition. In addition, it was found that temperature fluctuations in the drying oven also affect the final result of painting. Ovens that are unable to maintain stable temperatures have the potential to cause paint layers to dry too quickly or too slowly, both of which can result in thickness not meeting standards. Another related issue is the suboptimal performance of the air circulation machine, which is responsible for maintaining airflow in the spray booth area. If this machine does not function properly due to lack of maintenance, it can cause disturbances in the direction and consistency of paint spraying.

The environmental factor also contributes to the occurrence of under paint defects in the spray painting process. It is known that several environmental factors that cause NG total defects also directly affect the emergence of Under Paint defects. One main factor is the dusty working area condition, caused by weak housekeeping programs and suboptimal cleanliness control in the spray booth area. Dust particles floating in the air or sticking to the material surface before painting can interfere with paint adhesion, so the paint layer does not adhere properly and results in uneven thickness. In addition, inadequate ventilation in the spray booth area causes airflow disruption during painting, which can affect the direction and distribution of paint spray, resulting in some surface areas becoming under paint. Poor lighting in the working area also hampers operators in accurately monitoring paint thickness during the spraying process. On the other hand, excessively hot area temperatures due to poor air circulation cause the paint to dry before it spreads perfectly on the surface, increasing the risk of overly thin paint layers. Therefore, these environmental factors, which previously also contributed to NG total defects, have proven to significantly affect the stability and quality of paint thickness, and need to be a focus of improvement efforts to enhance the quality of the painting results.

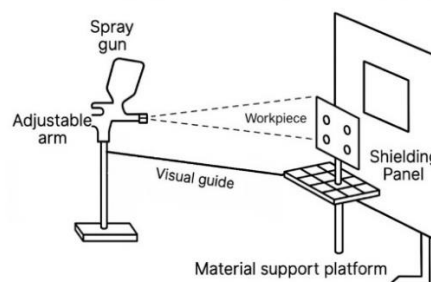
**Figure 3. Prototype of Spray Painting Assistive Tool Development**

The third-largest contributing cause of defects, especially under paint, is the inconsistency in spraying techniques among operators. The thickness and evenness of the paint layer on the material are highly influenced by variations in distance, angle, and spray direction. This issue is classified as human-dependent variability, which may be difficult to resolve through training or instruction improvement alone.

The proposed solution is the development of spray painting assistive tools designed to make the manual painting process more controlled. This solution aims to help operators maintain consistent spraying distance and direction through a combination of features such as a spray gun support arm, a rotating material platform with a fixed height, shield panels to prevent overspray and wind disturbance, and a visual spray distance guide.

- **Shield panel:** This feature acts as a barrier on the sides and back of the painting area to prevent paint from spreading outside the target area (overspray) and to reduce disturbances from airflow that can cause uneven spray distribution. The shield panel also helps maintain consistent paint coverage on the material surface.
